SAMPLING PLAN

**33777 Valley Center Road
in
Valley Center, California**

DATE: Revised, April 30, 2008

PROJECT NUMBER: 08-0311

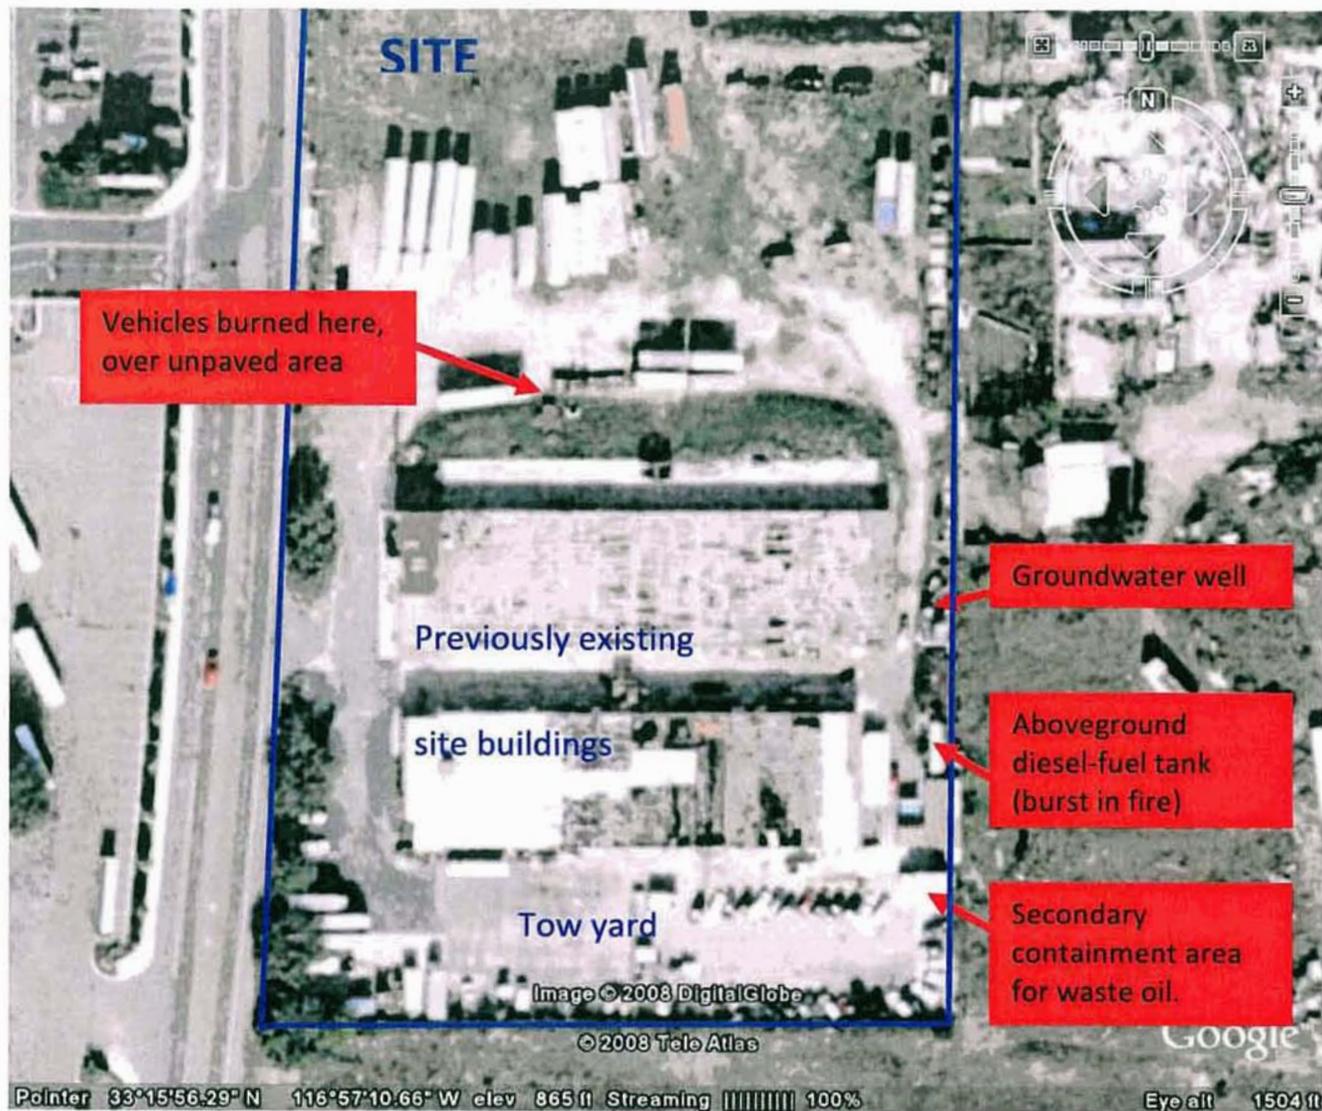
APPENDIX I MAP OF SUBJECT SITE (HIGHLIGHTING AREAS OF INTEREST)

Photo Source: Google Earth 2007 Edition
(from photograph prior to 2007 fire)

- 1- Soil from the unpaved area alongside a secondary containment structure for waste oil (located along the east side of the subject site, near the northeast corner of the lot previously used by the towing company). If no basis for location selection bias exists, select two locations randomly about one foot from the north and south corners of the containment.

- 2- Soil from unpaved areas beneath and alongside the aboveground storage tank (used for diesel fuel), located near the center of the east side of the subject site. If no basis for location selection bias exists, select three locations at 25-, 50-, and 75-percent points along the area's longest dimension. Samples will be taken from near-surface (ca. 0.5-foot deep) and shallow (1-to-2-foot deep) soil.

- 3- Soil from the unpaved area immediately north of the paved center of the subject site and the previously existing buildings, where several vehicles were destroyed by fire and
